Corrosion degradation and repair of a concrete bridge

A. Guettala · A. Abibsi

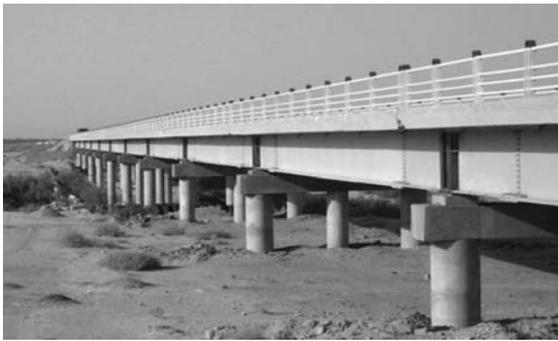
It is about a horizontal mixed bridge of an overall length of 340 m, made up of 11 isostatic spans of 30 m each. The 10 m wide deck is composed of three metallic girders of 1.50 m height. These girders are linked by two butt-spacers, three intermediate-spacers and surmounted by a reinforced concrete slab. Its profile consists of an 8 m width roadway framed by two pavements of 1 m width. The roadway support is made of two reinforced concrete supports with wing walls

Fig. 1 General view of the bridge.

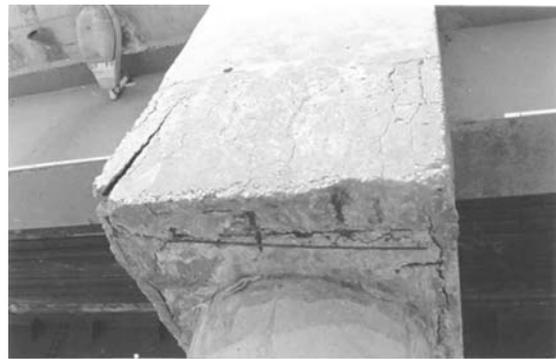
The bandages are mostly affected, some of which badly, Fig. 3. The degradations are of the following forms:

- advanced corrosion of the reinforcement;
- concrete spalling;
- multi-directional cracking of the concrete.

Fig. 3 Degradation of the cross beams.

It is at the girder ends that degradations are significant. In their median part, they are only slightly degraded. This can be explained simply by the stagnation of water at ends.

It was observed that the joints of roadways at the pavement level were not tight and this allowed rainwater to penetrate through the joints and pouring on the bandages where they are retained by the hidden walls before running out on the piers. The badly designed metal sheeting embankments form a basin like, retaining thus water.

The degradation was very significant in places of water flow indicating that the rain water is unusually very aggressive. The rain water analysis indicated that it is unusually very salty. After investigation, it appeared that the rain water salt content resulted from salts falling off the trucks making the shuttle between the salt layer, about 40 miles from Biskra. The rain helps the leaching of the deck and dissolves the salt. The resulted salty water penetrates through the loose inter-spans joints. Therefore, the principal cause of degradations is the chemical attack by the chloride ions causing the corrosion of the reinforcement and consequently the bursting of the concrete. The concentrated degradation at the level of the ends of the bandages is probably related to the bandages roof shape (symmetrical cross fall of 2.5%). The lack of cover (wrapping) in certain places; the bad quality of the concrete used indicated by the state of the facade and the presence of the gravel niches contributed enormously to corrosion of steels.

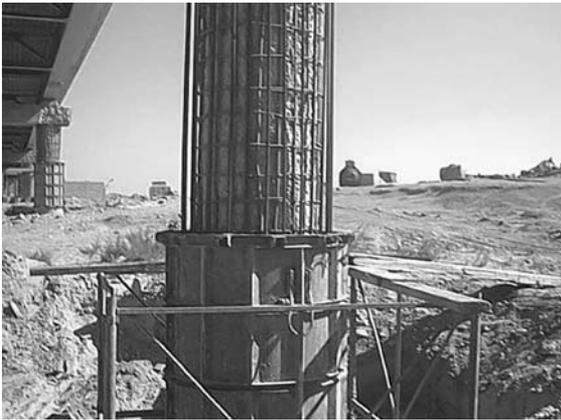
Fig. 4 Repair of pier.

- Remove all the loose and spalled concrete along the whole wall height (including the buried parts) until reaching the steel.
- Expose the reinforcements at least 2 cm beyond the cover.
- Remove all the corrosion products from the reinforcement bars by sand blasting. This operation must be done perfectly well.
- Rinsing and blast cleaning of all the concrete surfaces;
- The non-exposed bars to be sand blasted and cleaned with metallic brushes
- Treat the corroded reinforcement using an anti-corrosion product generally in the form of

- Strengthen the affected reinforcement by adding new bars and making sure of the total covering at pier base; if the existing bars are corroded.

The framing, preferably, metallic, must be provided with spacers intended to ensure the wrapping of the reinforcements with an increase in the diameter of the piers by 20 cm compared to the initial diameter. This increase in the section will facilitate the casting of the concrete and also reinforce the pier resistance, Fig. 4.

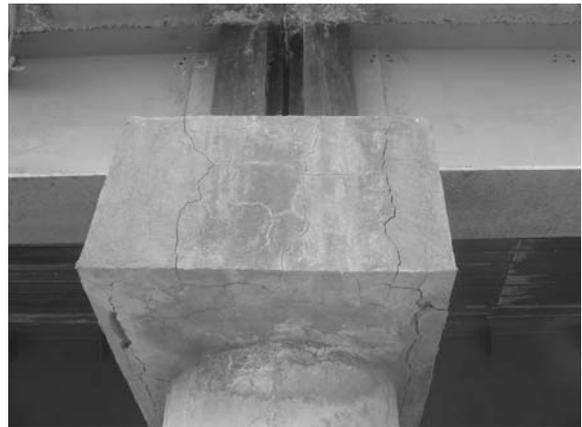
The bandages are mostly affected, mainly at their ends. The degradations started by the cracks formation at the end of all the bandages. These cracks are as large as 10 mm.

Fig. 5 Multi-directional cracking of the concrete. After repair.

Some of the bandages have shown cracks in all directions, Fig. 5. The formation of these cracks is certainly due to the reinforcement corrosion which arises from the fact that the work repair had not been carried out properly, poor corrosion product removal during repair.

The removal of the corrosion product must be done properly. If this is not the case, it's possible that the corrosion process will continue after repair, especially in the case of chloride induced corrosion as in our case. Special care must be taken to ensure the cleaning efficiency. This has not been done because of probably the difficulties encountered during repair. Besides, the mortar layer used was very thin, only the degraded part concrete has been replaced. What have caused and accelerated the corrosion phenomenon was the rain water flow through the pavement joints which were not so tight, Figs. 6 and 7.

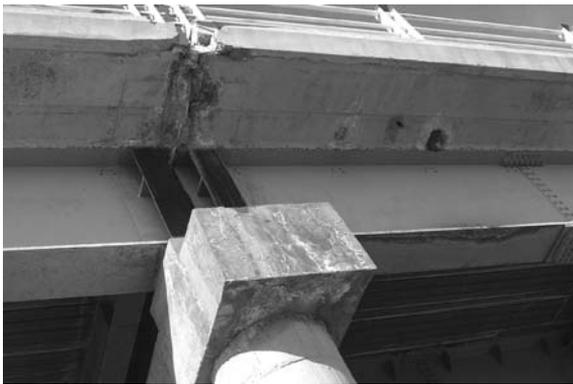
We noticed that where there are signs of water flows, the degradations were very significant indicating that the rain water is still very aggressive.

Fig. 7 Heavy water flow traces indicating very poor jointing and defective rain water.
