MASTER'S DISSERTATION

Theme: The effect of constraints and uncertainties on project time management. A Case Study of Djemorah swimming pool, Biskra.

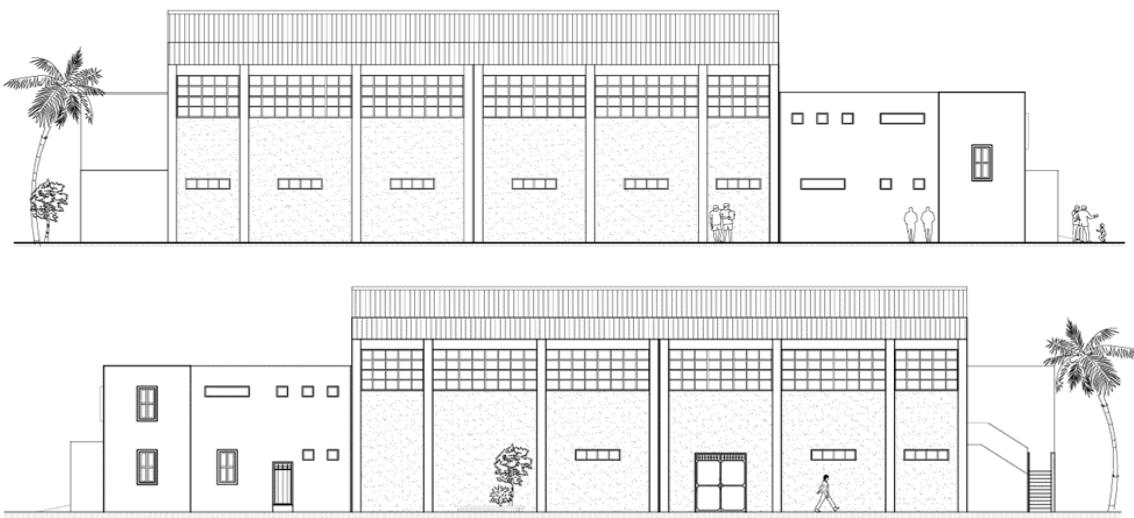
Figure 16. North and South facades (Source: Directorate of Youth and Sports, 2025).

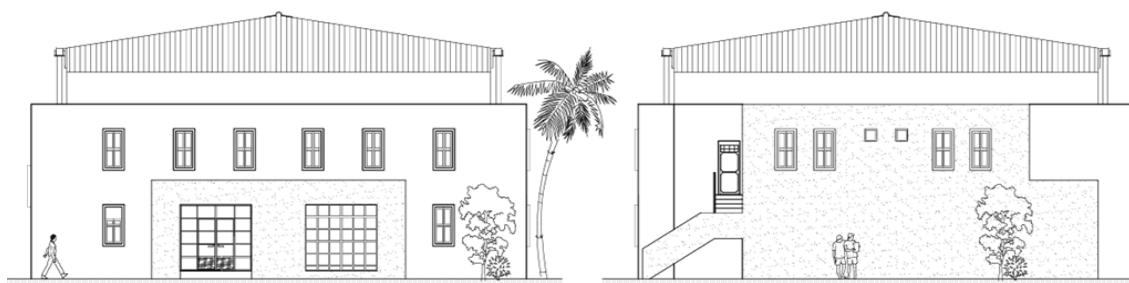
The east and west façades show a simpler, more utilitarian aspect with smaller, square windows and a visible external stairway on one side, matching the narrative of contrasting volumes and functional design elements. Overall, the façades accurately reflect the modern, minimalist aesthetic and functional clarity outlined in the previous paragraph, providing an effective architectural expression that balances utility with clean, articulated massing.

Figure 17. East and West facades (Source: Directorate of Youth and Sports, 2025).

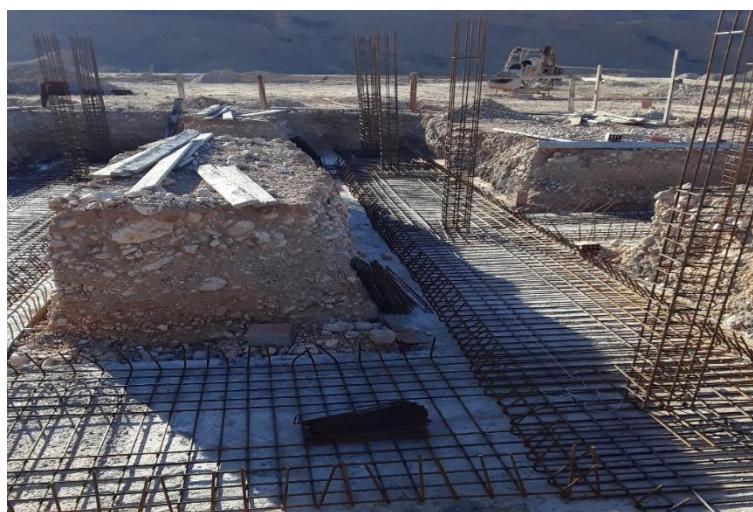
Initial progress stood at approximately 30% completion as of December 2021. By February 2022, the project advanced significantly, reaching around 50% completion with the inclusion of backfilling activities. These preparatory steps were fundamental to establish a stable and well-prepared foundation.

Figure 21. Placement of foundation reinforcement (Source: Author, 2025).

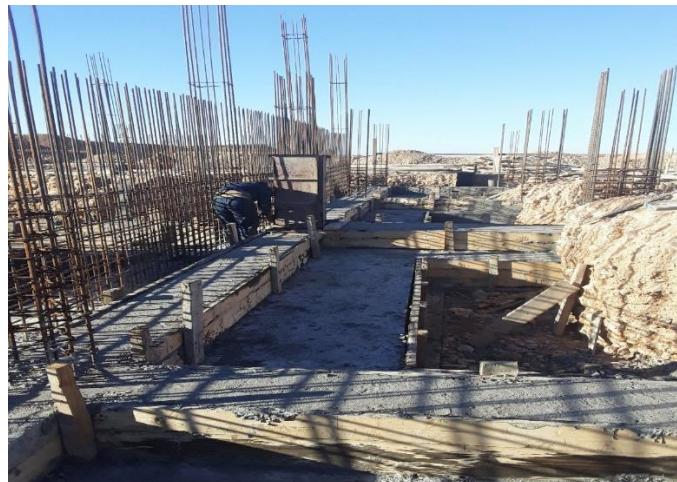
Figure 22. Pouring of foundation concrete (Source: Author, 2025).

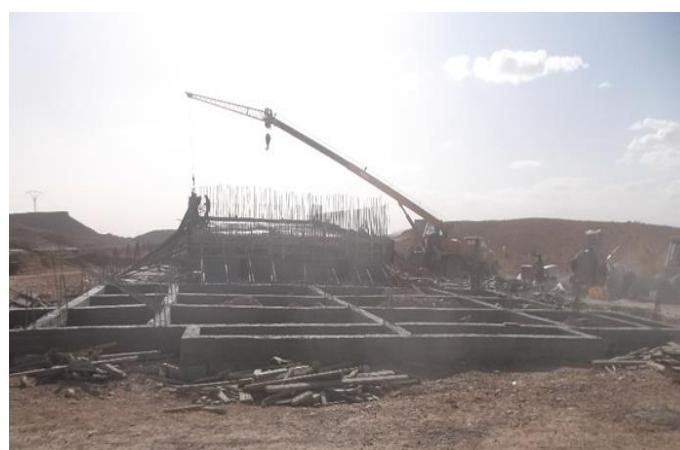
As of April 1st, 2022, the construction progress of the Djemorah semi-Olympic swimming pool was substantial across multiple components. Earthworks were nearing completion at 90%, with only external landscaping remaining.

Figure 23. Casting of foundation column concrete elements (Source: Author, 2025).

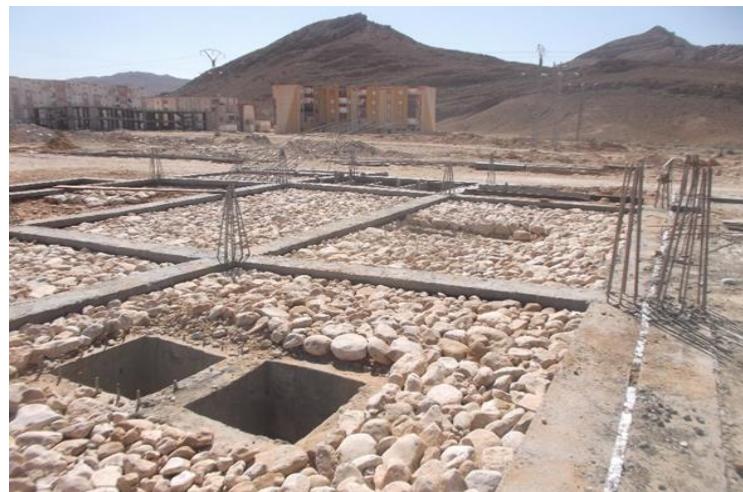
Inspection chambers, connection boxes, and gutters reached full completion at 100%, while gravel bedding was at 70%, and the floating slab was complete. In terms of superstructure works, the basin slab was entirely finished, while basin walls remained at 50% completion. The water tank had its major works fully completed, with finishing and equipment installation still pending.

Figure 24. Placement of insulating stones for the ground layer (Source: Author, 2025).

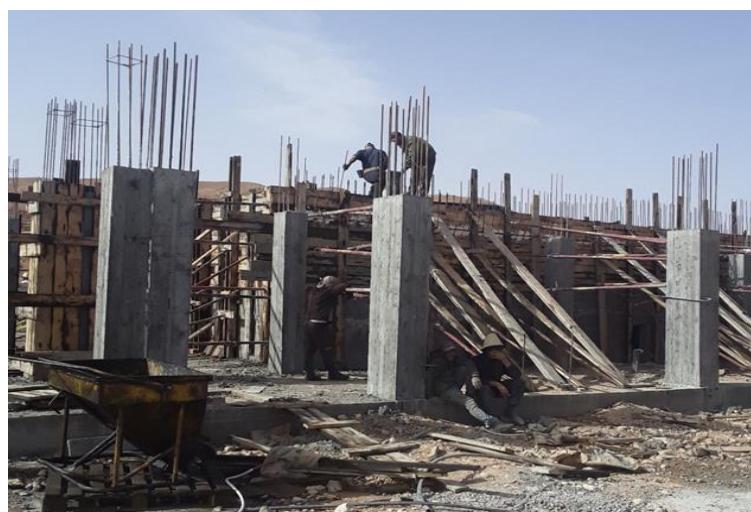
Earthworks remained at 90%, with the focus on remaining external landscaping. Substructure elements, including foundations, column bases, and ground beams, were fully completed at 100%, as were inspection chambers, connection boxes, and gutters.

Figure 25. Casting of ground floor column concrete (Source: Author, 2025).

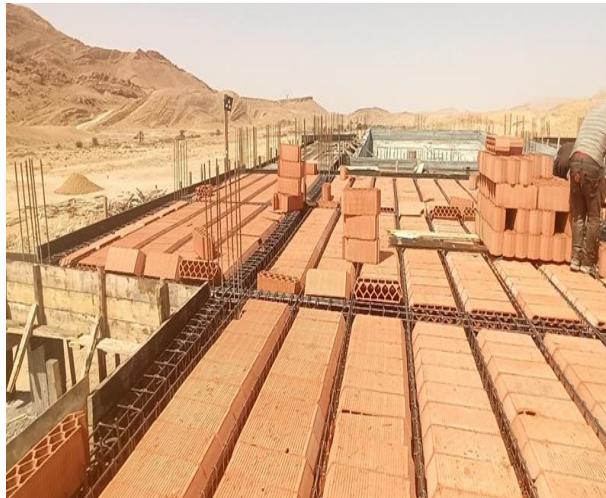
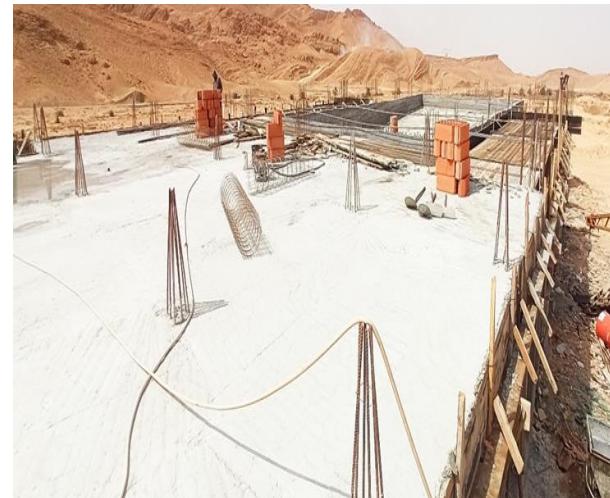
Overall slab works, encompassing both hollow-core and solid slabs, reached approximately 45% completion. The water tank's major works were fully completed, with masonry, equipment installation, and finishing works pending. This detailed account reflects diligent construction management and consistent advancement towards project finalisation.

Figure 26. Start of concrete casting for the ground floor slab (Source: Author, 2025).

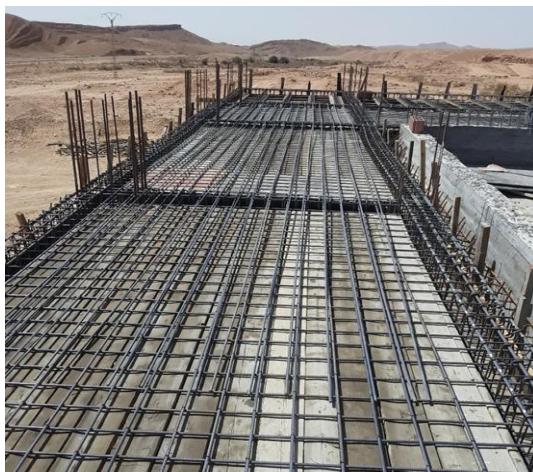
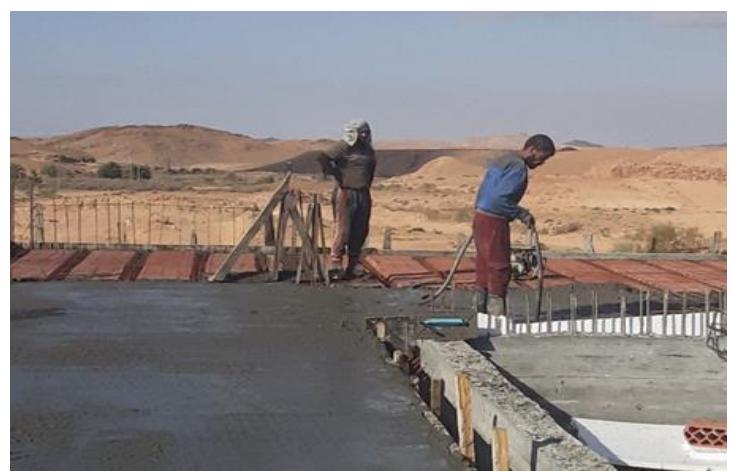
The fence construction had not yet started. The project's overall progress was approximately 55%, reflecting effective project management and advancing structural completion toward finalisation.

Figure 28. Casting of the first floor slab concrete (Source: Author, 2025).

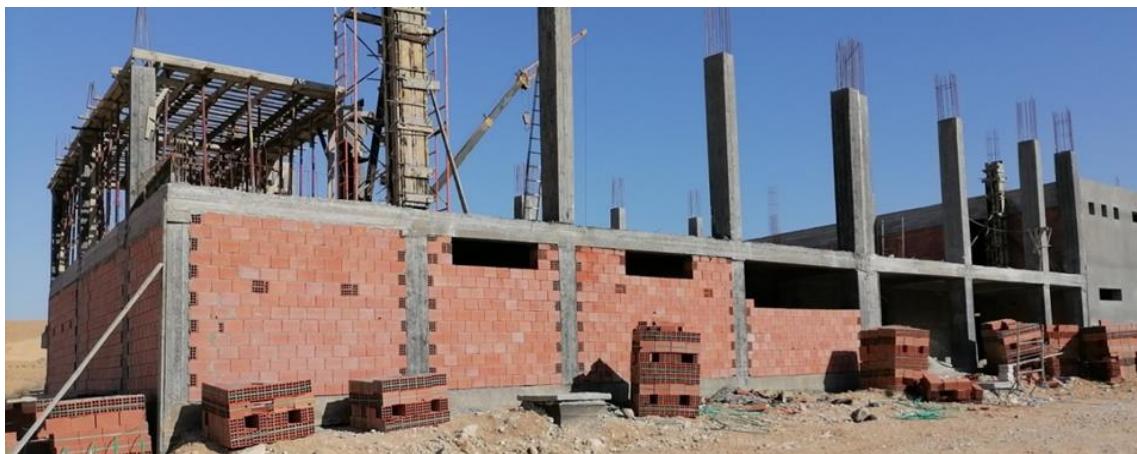
Major works on the water tank were finalised; however, finishing works were still pending. Fence works had yet to commence. Overall, the project was approximately 60% complete, reflecting robust project governance and consistent progress towards the finalisation of this valuable community asset.

Figure 29. Stripping of formwork for first floor columns (Source: Author, 2025).

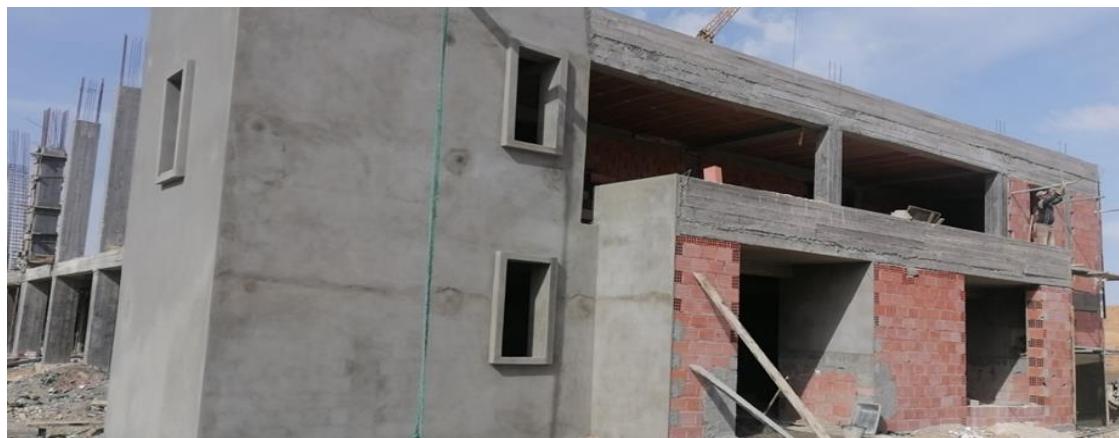
Figure 30. Cement plastering works on the first floor walls (Source: Author, 2025).

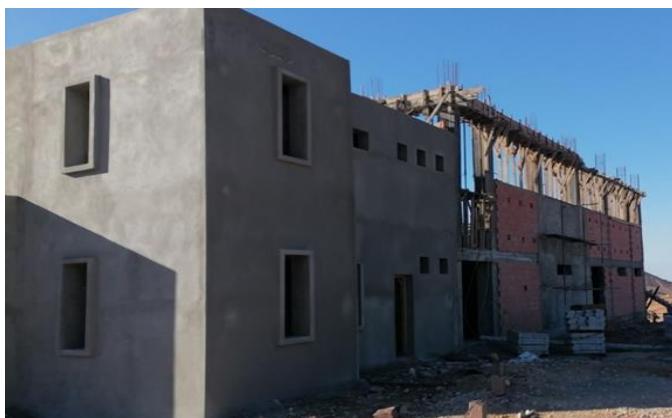
Figure 31. Progress of exterior plastering works on the first floor walls (Source: Author, 2025).

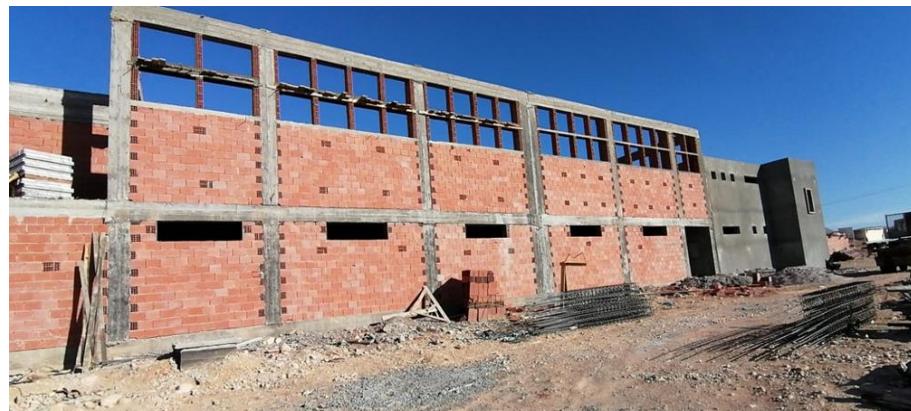
Figure 33. Setting out and defining the lighting openings on the first floor (Source: Author, 2025).

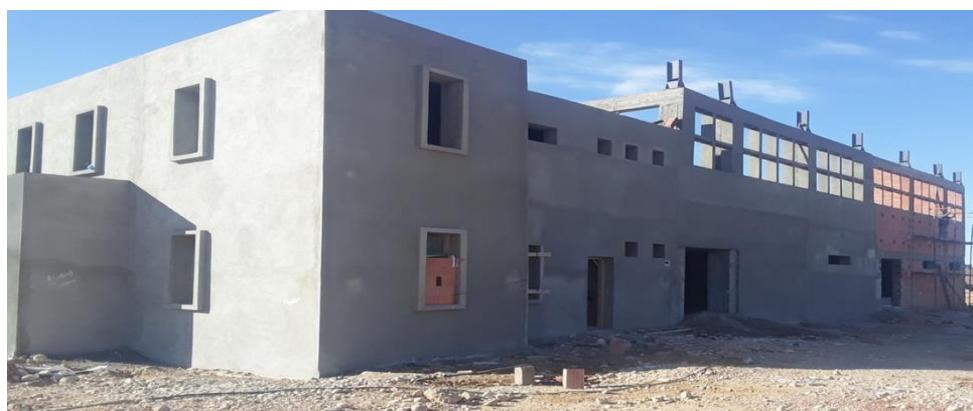
Figure 34. Exterior view showing the completion of first floor wall plastering and lighting window openings (Source: Author, 2025).

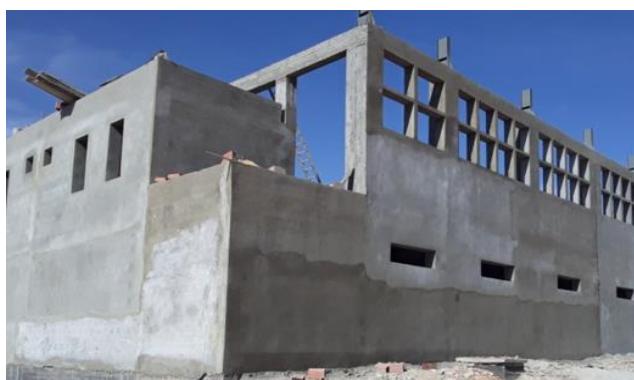
Figure 35. Execution of full exterior cement plastering works on the building façade (Source: Author, 2025).

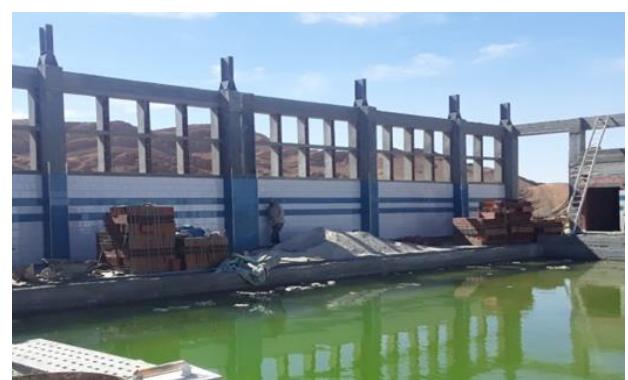
Figure 36. Beginning of interior wall tiling works with swimming pool faience (Source: Author, 2025).

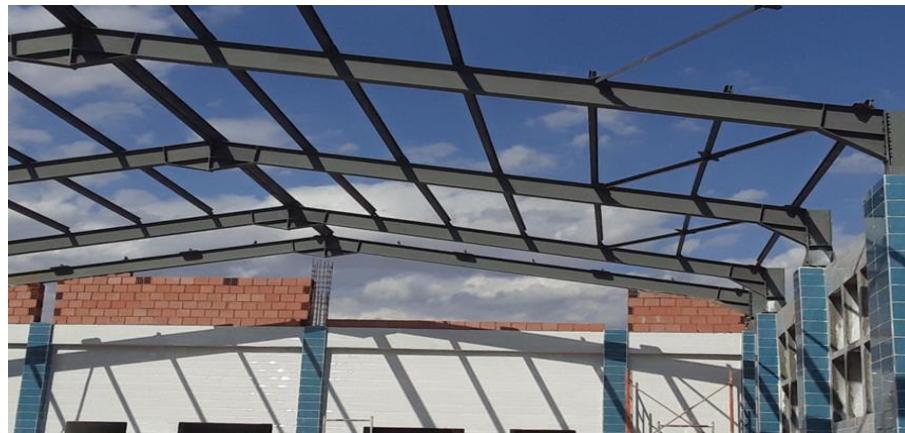
Figure 37. Installation of the metallic structure for the swimming pool roof (Source: Author, 2025).

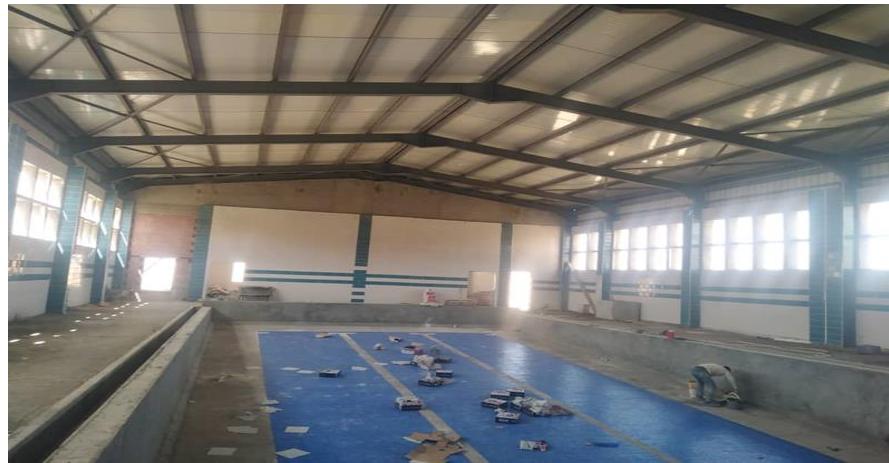
Figure 38. Covering of the metallic structure of the swimming pool roof (Source: Author, 2025).

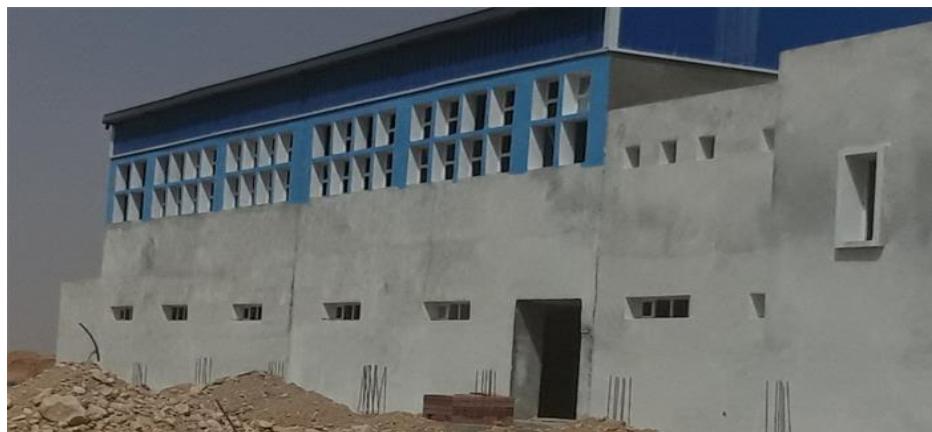
Figure 39. Execution of exterior wall painting works (Source: Author, 2025).

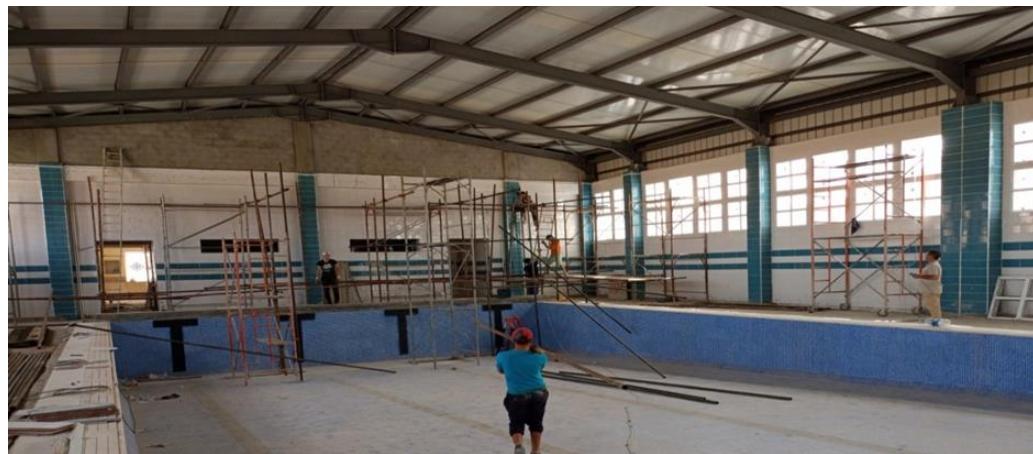
Figure 40. Finalisation of interior finishing and fitting works in the swimming pool hall
(Source: Author, 2025).

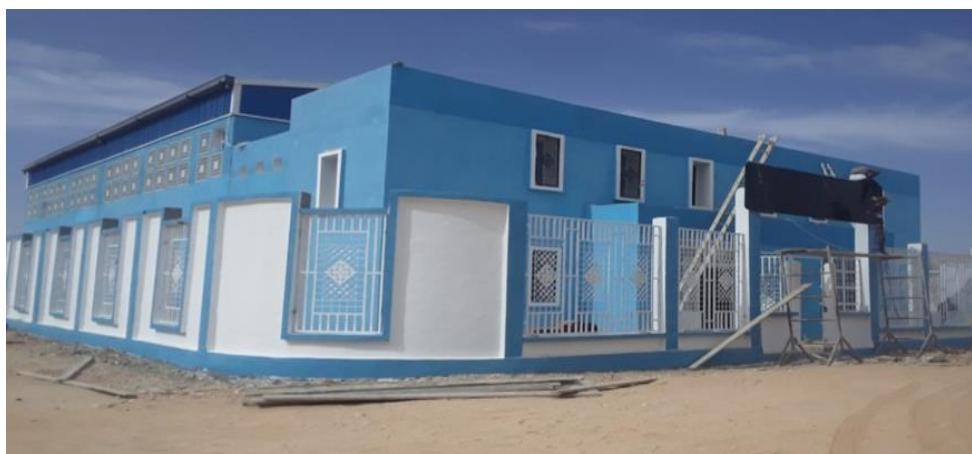
Figure 42. Completion of exterior painting and site landscaping around the swimming pool (Source: Author, 2025).
